RESEARCH OF A HIGHLY DEFECTIVE FROG CORE OF GRADE 1/9

For the first time at the Riga Technical University a study was carried out of a highly defective frog core of grade 1/9. In the course of the research an analysis of crossing piece defects on the Latvian railway was carried out in eight railway sections during years of 2015, 2016, 2017. The defect of the frog core of grade 1/9 (the **60 E1 DO 07 12** frog type) was considered according to the basic classification of the defects, and the analysis and research of the cause of its fracture were conducted from the bolt hole to the web and the base of the frog core.

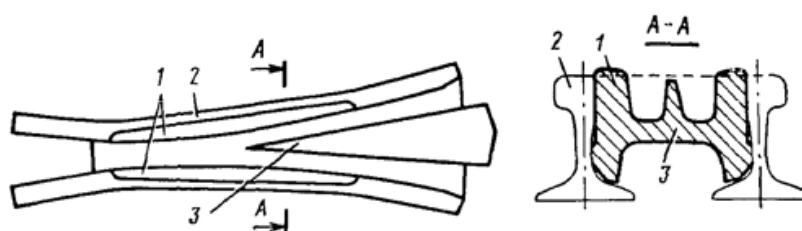
Figure 2. Bolted frog with cast core of general casting type with wearing part of wings: 1 – wearing parts of wings; 2 – wings; 3 – core.

The bolted frogs with a cast one-sided core of the general casting with the wearing part of the wings are commonly used among **frogs with cast core** in the Russian Federation (Figure 2). In such frogs, the core and wearing parts of the wings have single monolithic structure cast from high-manganese steel. The core is attached to the wings, made of typical rails. The tread surface of cast parts of wings (Figure 2) is raised by 5 mm above the tread surface of the track rails, like the wings of solid frogs. These frogs, in comparison with the bolted-rail, have a longer service life and significantly fewer parts. Such frogs are widespread in the USA. At the same time, the connection of the frog members is less stable in comparison with the solid ones. In addition, the design is quite complicated; both curvature and profiled cutout is required during manufacturing wing rails.

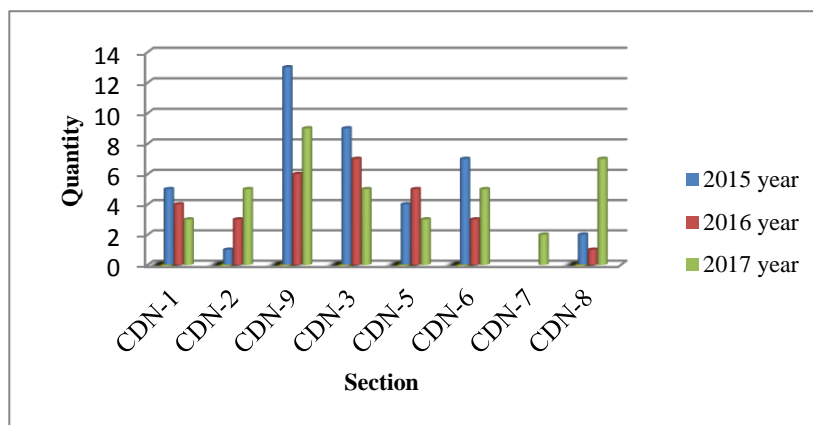
Figure 3. The diagram of highly defective rail members from 2015 to 2017

In 2015, 41 highly defective pieces had been registered on the Latvian railway. However, the number of highly defective pieces decreased from 41 to 29 cases between 2015 and 2016 and then increased again to 39 cases in 2017, as shown in the diagram (Figure 3).

It follows from the diagram (Figure 3) that in 2015 the largest number of rail defects was detected in the **CDN-9** Riga Department (13), and rail defects were not found in the **CDN-7** Lepaja Department. In 2016, rail defects (7) were detected in the **CDN-3** Daugavpils Department. Rail defects were not found in the **CDN-7** Liepaja Department during 2016. In 2017, the number of rail defects increased up to 39 cases; in particular, 9 rail defects were detected in the **CDN-9** Riga Department by workers of the flaw detection service. Two rail defects were detected in the **CDN-7** Lepaja Department during 2017.

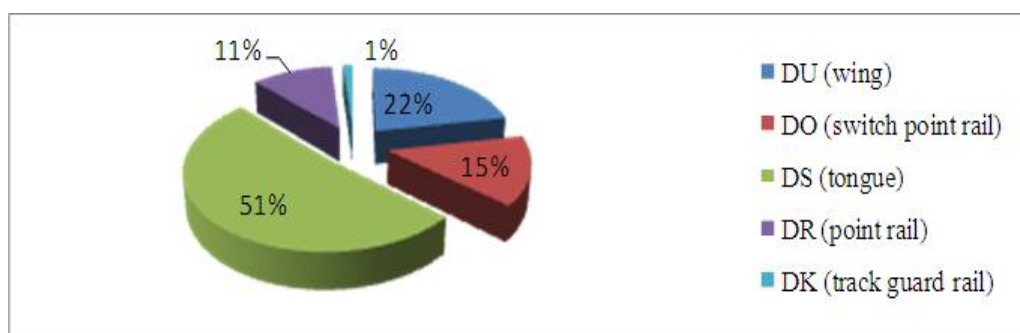
Figure 4. Distribution of defects in point switches in the places of their formation

The analysis of the statistics of the defects of point switches conducted on the railway network of JSC RR [13. Rozhdestvenskii, 2008, pages 201-211] showed that the greatest number of defects were detected in the frog cores of point switches. Distribution of defects by the members of the point switches is shown in Figure 4.

- Defects of wing (22%),
- Defects of switch point rails (15%),
- Defects of core (51%),
- Defects of point rail (11%),
- Defects of track guard rail (1%).

The defect code **C.53**. (Figure 4) is classified in the wing as cracks in the web from bolted or other holes in the rails. The defect code C.53. is subdivided into the C.53.1. and C.53.2. defect subcode, meaning that C.53.1 stands for a defect of the wing in the joint and C.53.2 stands for a defect of the wing located outside the joint. Stress concentration at the edges of bolt holes, absence or poor performance of chamfers, irregularities on hole surface due to poor drilling and corrosion accelerate development of cracks (Rozhdestvenski, 1993). Unsatisfactory condition of joints (weakening of bolts, crumpling and sagging of rail ends, subsidence in joints and presence of large gaps) may be the main reason for the appearance and development of this type of defect (Pramanick, 2017).

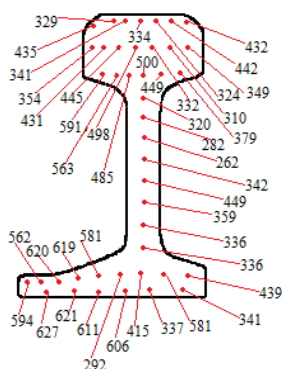
Figure.5. Determination of hardness of the frog core of grade 1/9 with 60 E1 DO 07 12 frog type in HB:
 in core top: 435, 329, 341, 334, 324, 442, 432, 354, 431, 445, 498, 332, 310, 349, 591, 563, 485, 500, 449, 379.
 in core web: 320, 282, 262, 342, 449, 359, 336, 336.
 in core base: 594, 562, 620, 619, 581, 292, 415, 581, 439, 627, 621, 611, 606, 337, 341.

The medium hardness in the core top is 416 HB, which is 47 HB exceeding the permissible value of the manufacturer (Dijs, 2016). During the research the medium hardness in the core web was 335 HB, which was 53 HB less. Based on the results obtained, the medium hardness in the base was 523 HB, which was 135 HB more than in the manufacturer's rated values.

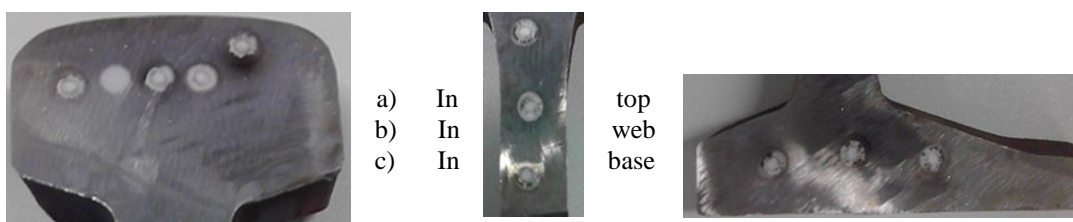
Figure.6 Determination the chemical composition in the three elements of the core

At Stage 2 of the research, the chemical composition of the metal was analysed at three points of the core (in top, web, and base). The specimen of a highly defective core was cut out with a circular saw from the frog core to be examined. This specimen was polished to a mirror surface using a power sander (Figure 6).

Comparing the basic, permissible values of the chemical elements of the composition of rail steel (Table 2, Table 3), the following conclusion can be drawn: the carbon (C) content is increased by 0.18% if compared to manufacturer's data. The chemical element silicon (Si) has the permissible percentage ratio and equals 0.406%. Test results show that manganese (Mn) content is normal (1.11%). Ratio of harmful impurities such as phosphorus (P) is increased 6.5 times, the excess being 0.106%, as well as the content of sulphur (S) is increased 3 times and the excess being 0.0389%. The content of aluminium (Al) was increased by 0.0039%. The chromium (Cr) content has the permissible percentage ratio and equals 0.0508% (Kapito, 2013). The percentage value of a chemical element such as nitrogen (N) was not revealed during the tests.

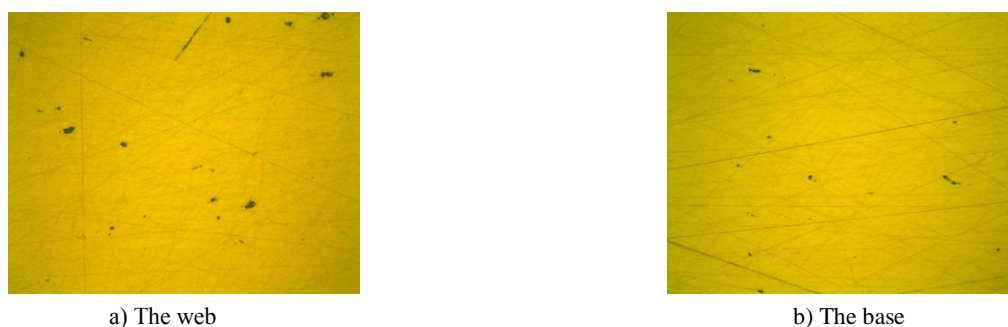
Figure 7. Determination of the metal structure under a microscope in web and base at X200 magnification

Studies in Figure 7 allow drawing the main conclusions about the quality of the rail steel of the frog core 1/9. In the obtained data small inclusions in the form of black spots were found in the metal structure. This fact also confirms certain chemical composition. Comparing the metal structure at the x200 magnification (neck) and x200 magnification (sole), various inclusions were found and, it is well known that inclusions can be a "nucleus" of the formation of cracks. The metal structure considered is an unconfirmed confirmation of the investigation of the chemical composition of the quality of the metal of the core of the 1/9 crosspiece.
