TRAGEDY IN ZOLITUDE – A LESSON FOR CONTEMPORARY SOCIETY

Sandra GUSTA, Department of Architecture and Building, Latvia University of Agriculture Street Akadēmijas 19, Jelgava LV-3001, Latvia, sandra.gusta@llu.lv

Keywords: durability of constructions, Maxima shopping centre, roof collapse, safety.

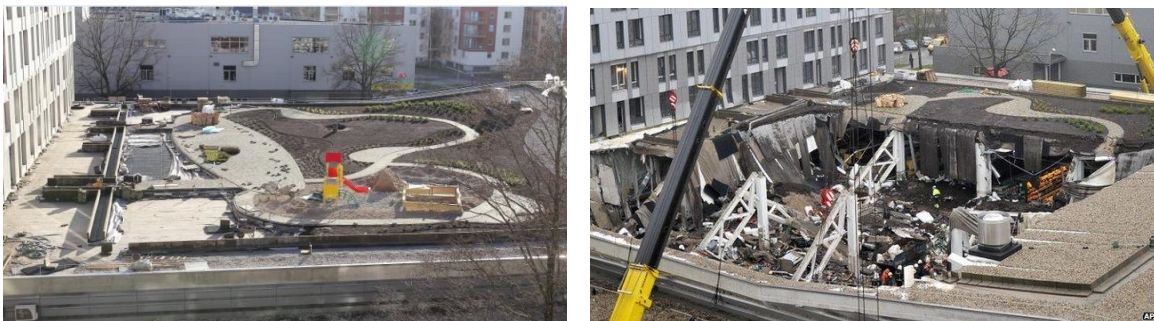
On November 21, 2013 the roof of Maxima shopping center in Riga, Latvia collapsed, causing 54 deaths and international news. The collapse of a supermarket in the Latvian capital Riga has been described as "murder", by the country's president Andris Berzins. It is the deadliest disaster in Latvia since it became independent in 1991.

Figure 1. Maxima shopping center roof collapsed in Riga (before and after roof collapse). Photo by Gatis Smagars (Latvia...,2013)

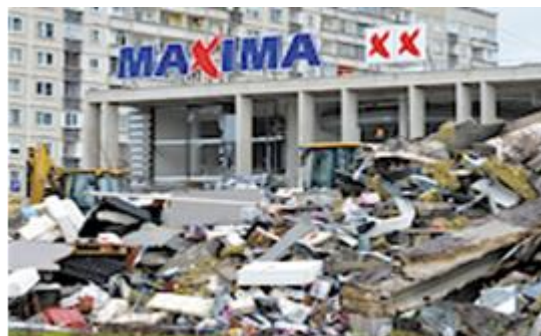
Figure 2. FLAWED: Inspections of buildings in Riga are exposing numerous problems (Lawsuit..., 2013)

Ongoing inspections by the Riga Construction Board of public buildings over the past several weeks have shown cracks of various sizes, specifically at 18 Rimi and 13 Maxima supermarkets in Riga. Overall, the Riga Construction Board has carried out inspections at more than 200 public buildings in Riga, including 100 Rimi, Supernetto and Maxima supermarkets, establishing "certain problems" in 31 of them.

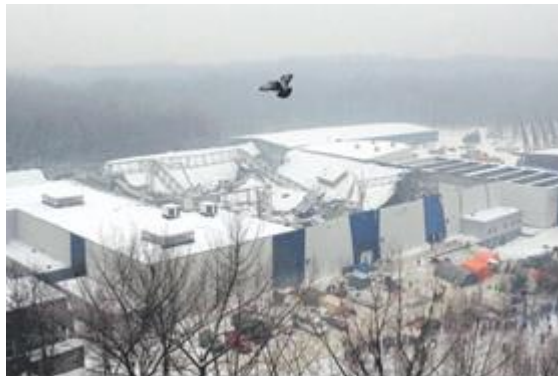
Figure 3. Tragedy in Katowice, Poland on 28 January 2006 (Kā Polijas..., 2013)

In general, the experts concluded that the major catastrophe was due to errors in the design, which changed several times in order to reduce the cost of building. It was also demonstrated that the company was aware of the problems and needed to clear the snow from the roof of the building, but ignored the warnings, not wanting to take on additional expenses (Kā Polijas..., 2013).

The investigation was completed in 2008, in late June. Katowice District Court in late July found the guilty ones of the tragedy, 12 persons were indicted, among them two hall designers, who were accused of "directly endangering lives of other people" and faced up to 12 years in prison.
