COMPARISON OF CONCRETE COMPRESSIVE STRENGTH VALUES OBTAINED USING REBOUND HAMMER AND DRILLED CORE SPECIMENS

Keywords: Rebound hammer, concrete core strength, reinforced concrete hydraulic structures.

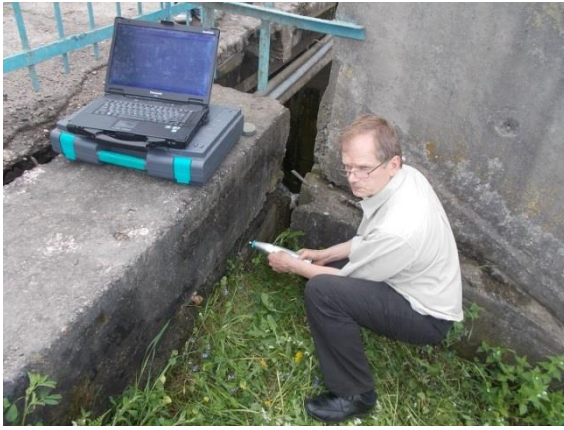
Figure 1. The estimation of compression strength using the non-destructive method

Using the non-destructive method with a rebound hammer of concrete Cat.58–CO181/N (Schmidt's system), an actual compressive strength of concrete was measured. The non-destructive testing of compression strength was performed in accordance with the Standard EN 12504-2:2012, using the Schmidt Hammer, the calibrated rebound device which was produced by the Swiss company "Proceq", serial No. N-34 160752. Before and after every examination, the device was calibrated using the standard anvil. The examination areas were prepared using abrasive stone (Fig. 1).

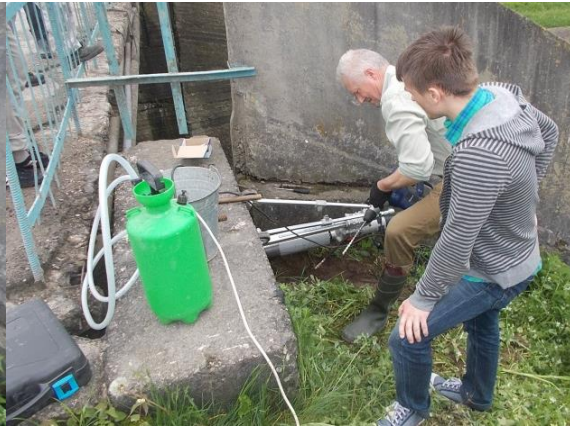
Figure 2. Cores' drilling process and device specification

In order to estimate the concrete compressive strength using the *destructive method*, cylindrical cores (diameter – 100 mm, height – 110-300 mm) were drilled (Fig. 2). The testing was carried out according to the requirements of the Standard EN 12504-1:2009 "Concrete testing in structures. Part 1. Cores. Sampling, observation and compression tests".

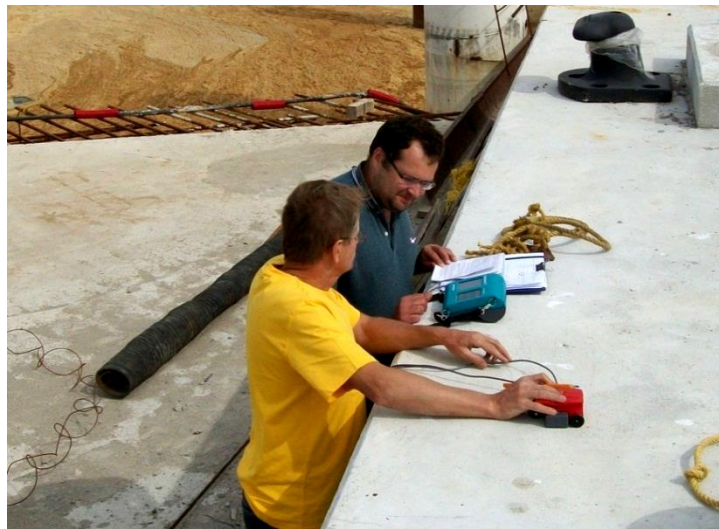
Figure 3. Defining position and depth of the armature using Profometer 5+ Scanlong

Before drilling, the position of steel armature and the thickness of concrete layer above it were being evaluated using Profometer 5+ Scanlong device (produced in Switzerland, "Proceq") in order to avoid the presence of armature in specimens, especially along the cylinder, as it disturbs the process of testing the strength of concrete (Fig. 3).

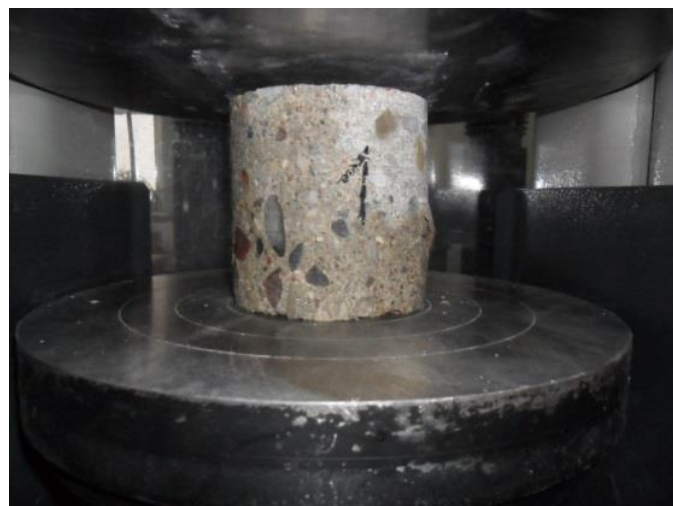
Figure 4. Compression test using hydraulic press *CONTROLS MCC 8*

The drilled cores were prepared by cutting off their ends and grinding them, after that they were tested in the laboratory using compression machine – hydraulic press *CONTROLS MCC 8* (Fig. 4.).

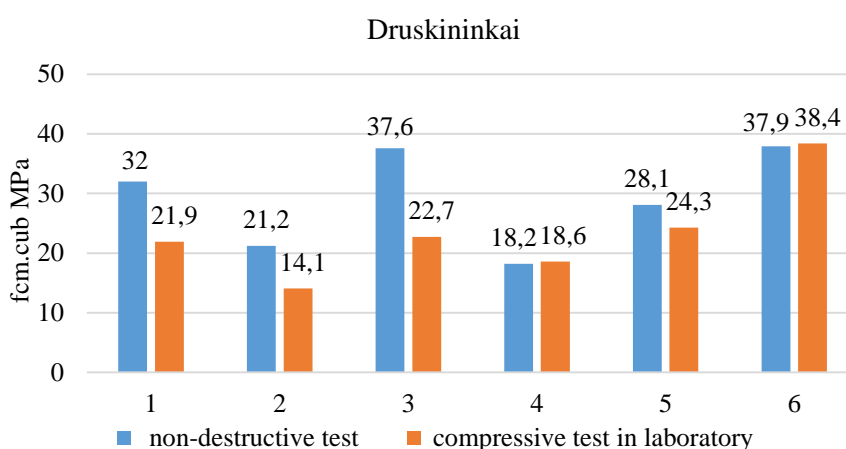
Figure 5. Compression strength of concrete in hydraulic structures of Druskininkai

By using the non-destructive method, the highest concrete compression strength $f_{cm}=37.9$ MPa of the transition zone of the second crosswall in the constructions of the pavilion of aerohydro-ionization therapy was determined. Then, according to the destructive method, a core was drilled from this wall and tested in the laboratory, finally, the highest concrete compression strength $f_{cm}=38.4$ MPa was determined. Having performed the non-destructive test, the lowest concrete compression strength $f_{cm}=18.2$ MPa was determined in the front wall of the transition zone and a very similar number $f_{cm}=18.6$ MPa was determined by performing the destructive test. Figure 6 presents the results which show, that the compression strength of 6 specimens determined using the non-destructive method is by 19 % higher than the one determined by means of compressing the cores.

The reinforced concrete strength f_{cm} of the constructions in the pavilion of aerohydro-ionization therapy, which is situated on Ratnyčia River in Druskininkai Healthcare Park was determined by using non-destructive and destructive methods. Figure 5 shows the results.

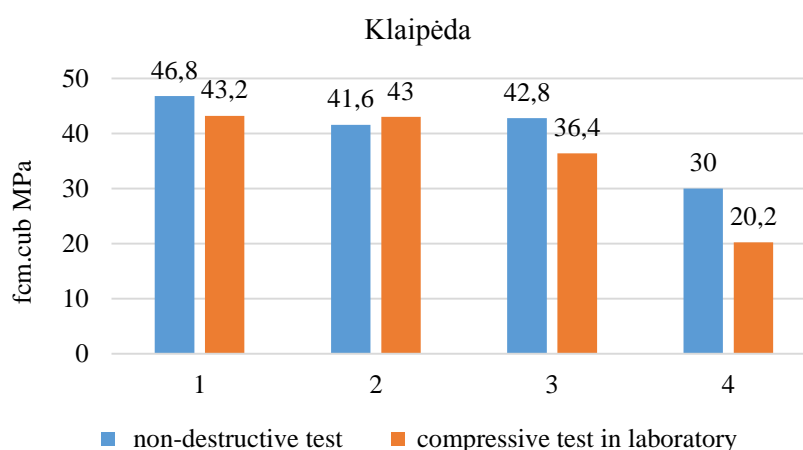
Figure 6. Compression strength of concrete in hydraulic structures of Klaipėda

By using the non-destructive method, the highest concrete compression strength $f_{cm}=46.8$ MPa was determined in the wall of the embankment No. 81, and the destructive test gave the result of $f_{cm}=43.2$ MPa. Next, by using the non-destructive method, the lowest concrete compression strength $f_{cm}=30.0$ MPa was established in the wall of the embankment No. 80, nevertheless the strength in this wall established using the destructive method $f_{cm}=20.2$ MPa was by 33 % lower. Figure 6 presents the results, which show that the compression strength of concrete f_{cm} of 4 specimens established using the non-destructive test, is by 12 % higher than the one established after the compressive test in laboratory.

The concrete compression strength f_{cm} of reinforced concrete constructions in the embankments No. 80. 81 situated in the territory of the Port of Klaipėda was established by using the non-destructive and destructive methods.

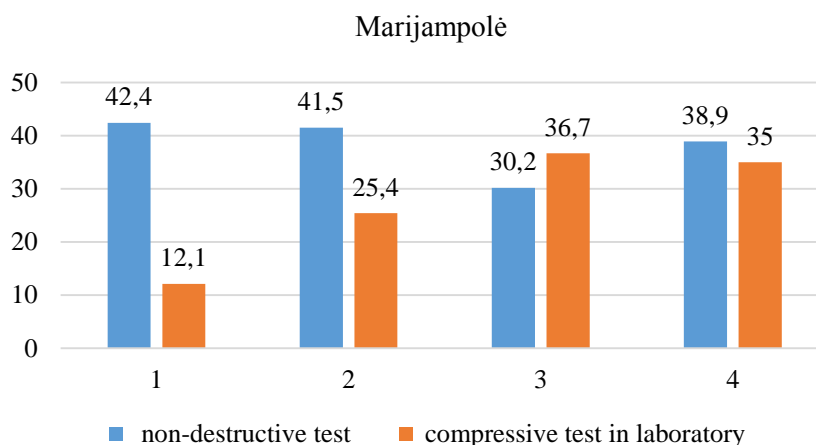
Figure 7. Compression strength of concrete in hydraulic structures of Marijampolė

After the the non-destructive test, the highest concrete compression strength $f_{cm}=42.4$ MPa of reinforced concrete constructions in hydroscheme of Marijampolė hydropower plant was determined in the wall of the right abutment of the downstream part, however the examination using the destructive method gave the result of $f_{cm}=12.1$ which is by 71 % lower. By performing the non-destructive test, the lowest concrete compression strength $f_{cm}=30.2$ MPa was established in the wall of the left abutment, however the strength in this wall established using the destructive method $f_{cm}=36.7$ MPa was by 22 % higher. As it can be seen in figure 7, the concrete compression strength f_{cm} of 4 specimens established using the non-destructive method, is by 24 % higher than the one established by performing the compression of cores.

The compressive strength of the reinforced concrete constructions in the hydroscheme of Marijampolė hydropower plant on Šešupė River is presented in figure 7.

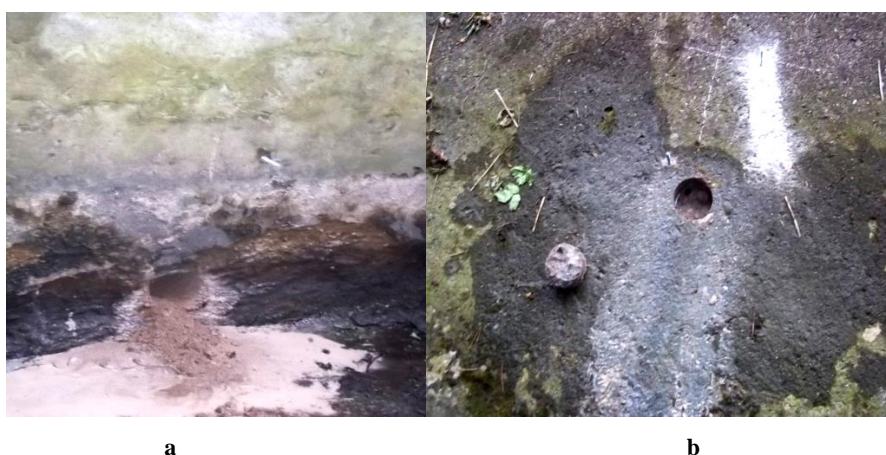
Figure 8. Failed extractions of cores when a) the strength of concrete was too low; b) the thickness of slab was too low
